City of Lake Geneva - Hillmoor Property Preliminary Vegetation Survey

Southeastern Wisconsin Regional Planning Commission

December 2025

City of Lake Geneva - Hillmoor Property Preliminary Vegetation Inventory

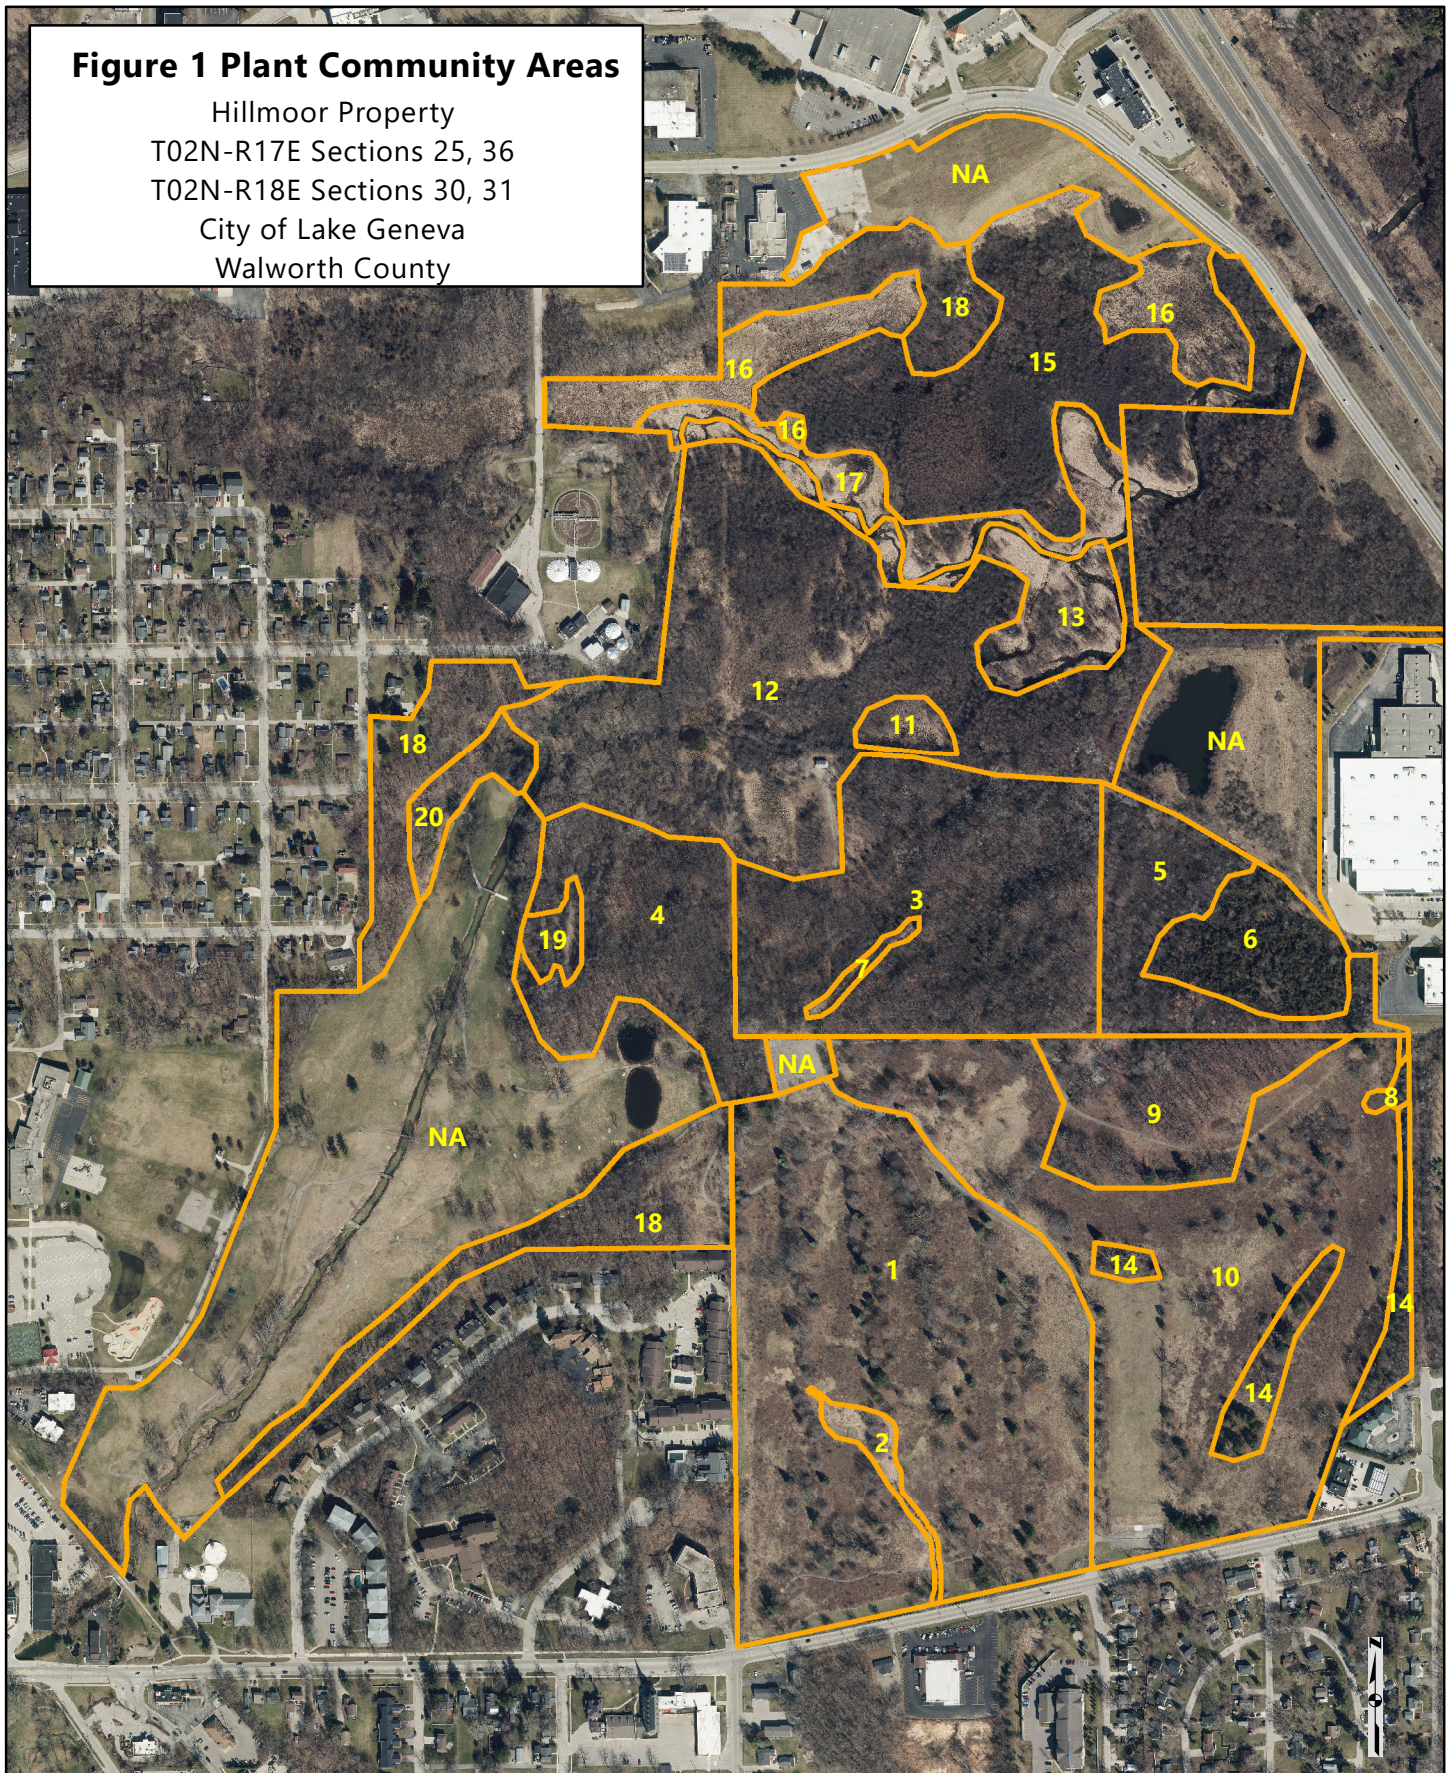
Figure 1 Plant Community Areas

Results of the preliminary botanical inventory within the subject parcels can be found in Exhibit A. Figure 1 provides an overview map of the property, identifying the location of each plant community area inventoried on the property. Polygons labeled with "NA" were not assessed as they were mostly open maintained parkland, lawn, or stormwater ponds. Each of the 20 plant community areas within Exhibit A contains a list of plant species identified within the unit, the total number of plant species, the number of non-native species, the mean coefficient of conservatism, and a brief narrative including the community type or types within the assessment area, acreage, historical disturbances, and management recommendations.
